Chumash Architecture: Sweatlodges and Houses

[Journal of California and Great Basin Anthropology, 17\(1\)](#)

# Chumash Architecture: Sweatlodges and Houses

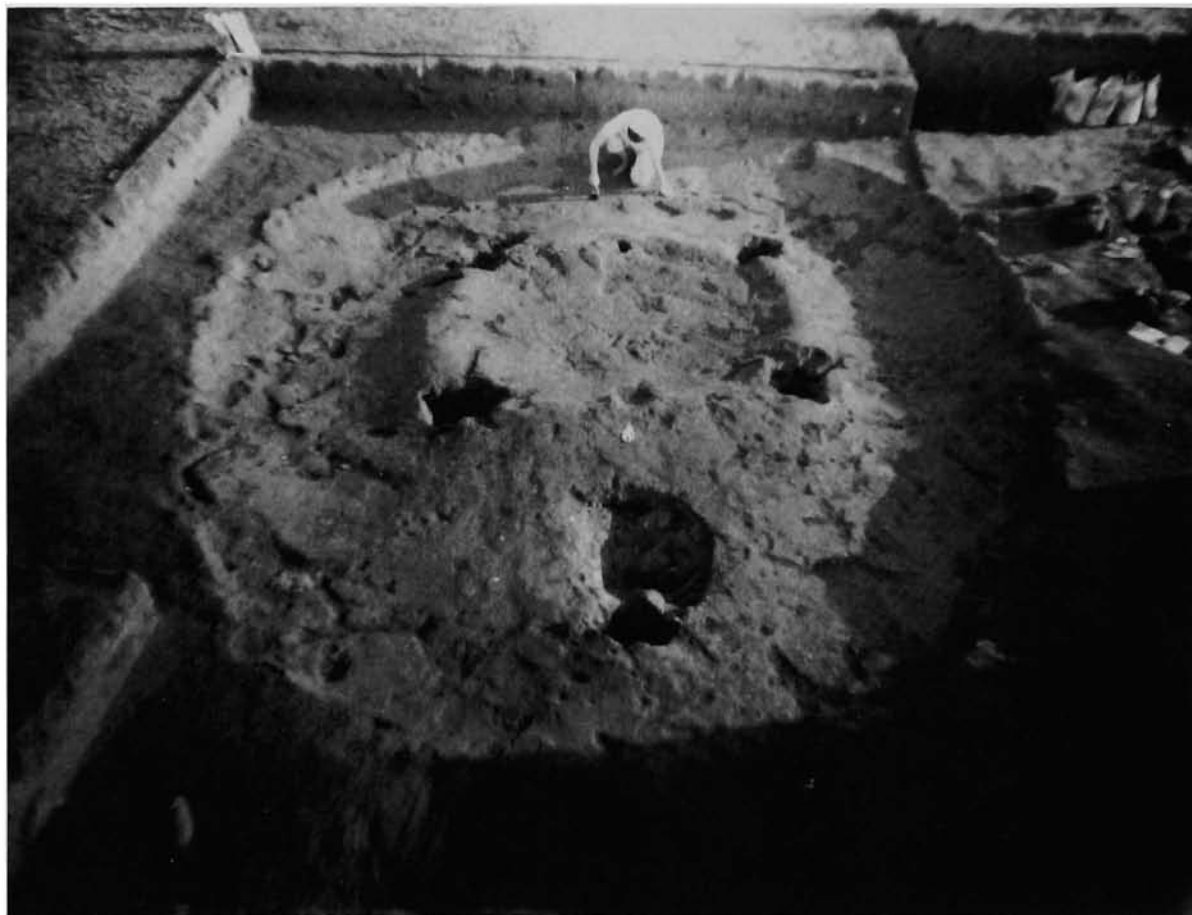
Fig. 1. Sweatlodge floor at Mikiw.

Although the actual floor was never removed or excavated, cross sections of it could be observed in areas disturbed by gophers. In several instances, four separate layers of plaster between 1/4-in. and 1/8-in. in thickness were observed. The plastered floor was peppered with fine grains of sand and small splinters of charcoal, shell, and stone. With the exception of the southern end, the rim was apparent around the entire periphery of the floor.

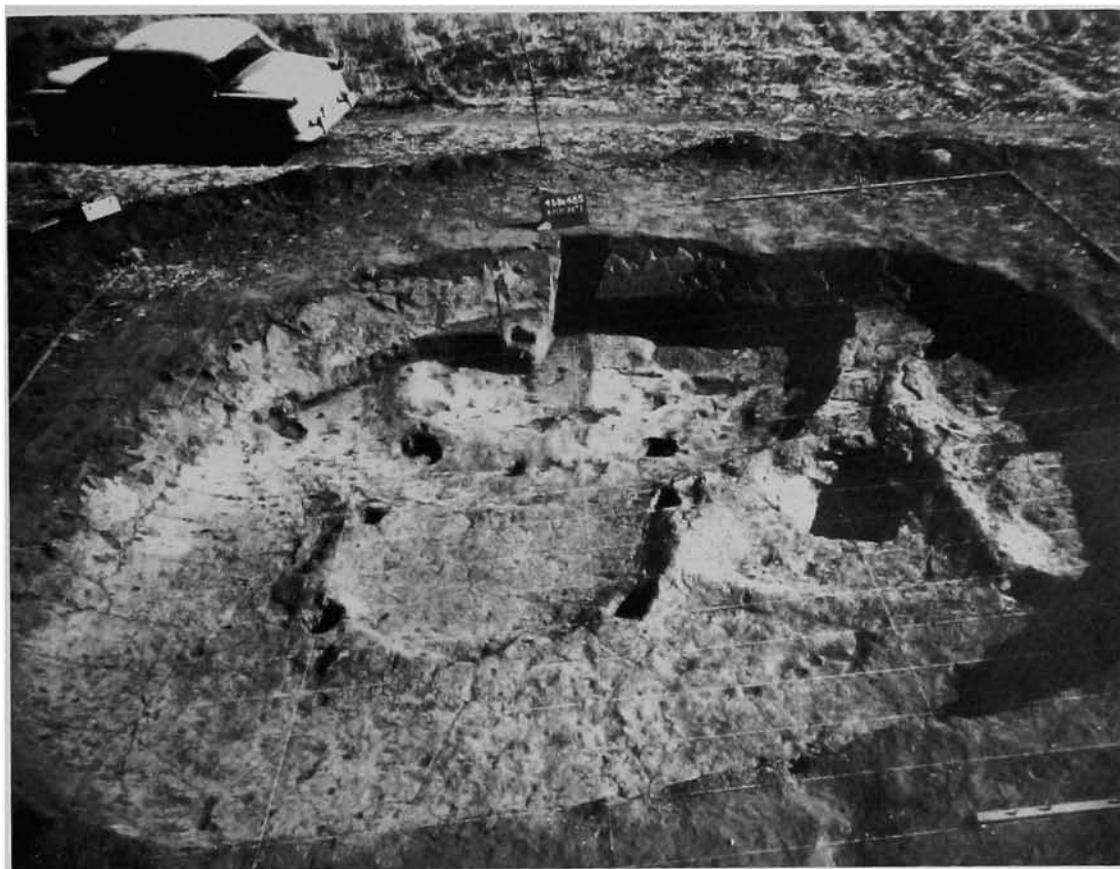
Fig. 3. Two sweatlodge floors at H'elxman.

H'elxman is a village site that is situated in the central Santa Ynez Valley, overlooking present-day Lake Cachuma. The remains of three floors at H'elxman were excavated by a variety of archaeologists, including Albert Mohr, William Harrison, Don Miller, and Jay Ruby. In 1959 and 1960, Harrison and Miller reexcavated Structure 1 to determine the similarities between this structure and the one at Mikiw. The only account of these excavations, other than the field notes, is a thesis by Macko (1983), who reviewed the notes and artifacts recovered from the site. Based on historic descriptions of sweatlodges and dwellings, Macko (1983:85) interpreted two of the structures at H'elxman as sweatlodges or "temescals" (Fig. 3). One of these, Structure 1, was about 22 by 27 ft. (6.7 by 8.2 m.) in diameter, and the other, Structure 2, was about 17 by 19 ft. (5.2 by 5.8 m.) in diameter (Macko 1983:Map 3). Structure 1 was superimposed over Structure 2 (Fig. 3; Macko 1983:95). Structures 1 and 2 have interior rims, large central postholes, and definite hearth areas near their exterior rim (Fig. 3; Macko 1983:88). The hearths were large and situated in the southern portions of the sweatlodges (Macko 1983:68). The interior raised rim was roughly square in plan view, and within it were large postholes. Both structures 1 and 2 apparently burned, as the remains of charred posts were observed in the postholes.<sup>5</sup> Structure 1 contained four large postholes on the interior rim. Macko (1983:92) noted that the types of features in Structures 1 and 2 were similar to those that one would expect to find in a sweatlodge. Miller (Horne and Miller 1978), also made these same observations. In addition, Miller noted that the floors associated with Structures 1 and 2 were more carefully constructed than the floor in the

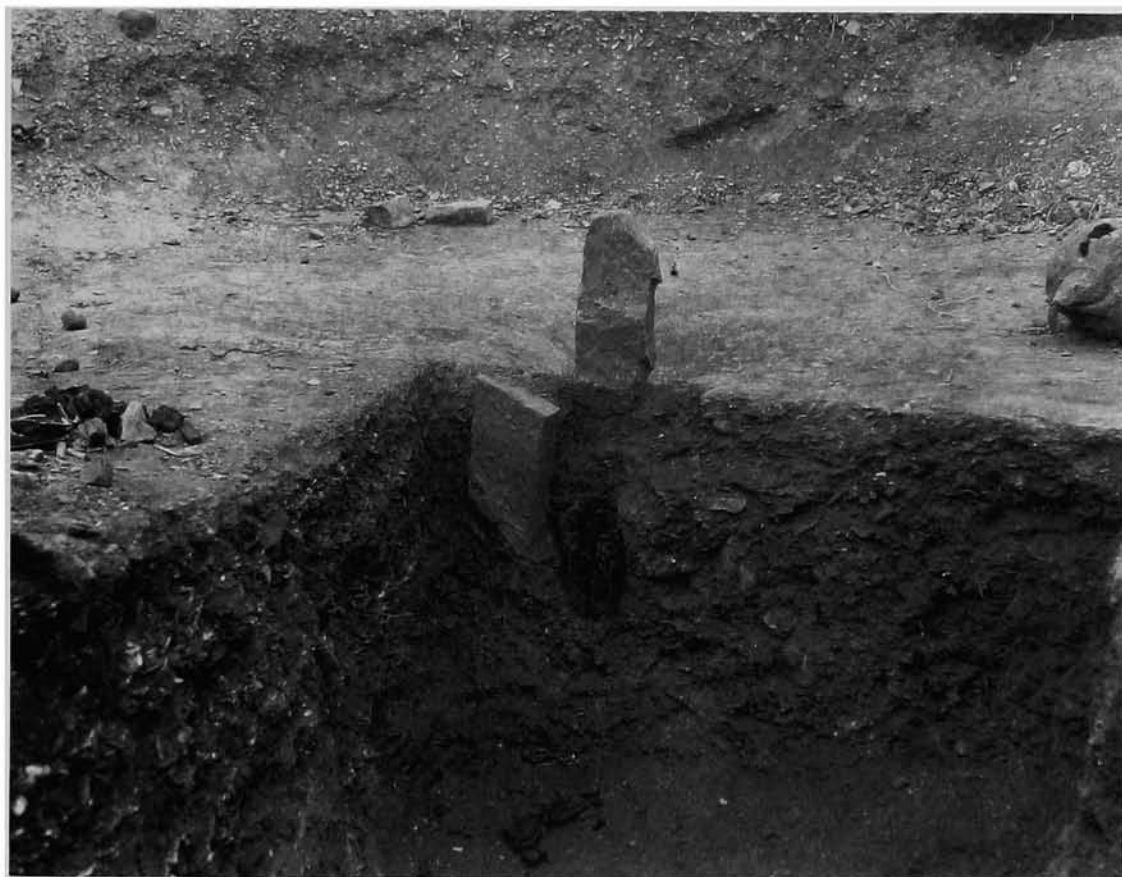
Fig. 4. Profile of center post and deflector rock in a sweatlodge at Muwu.

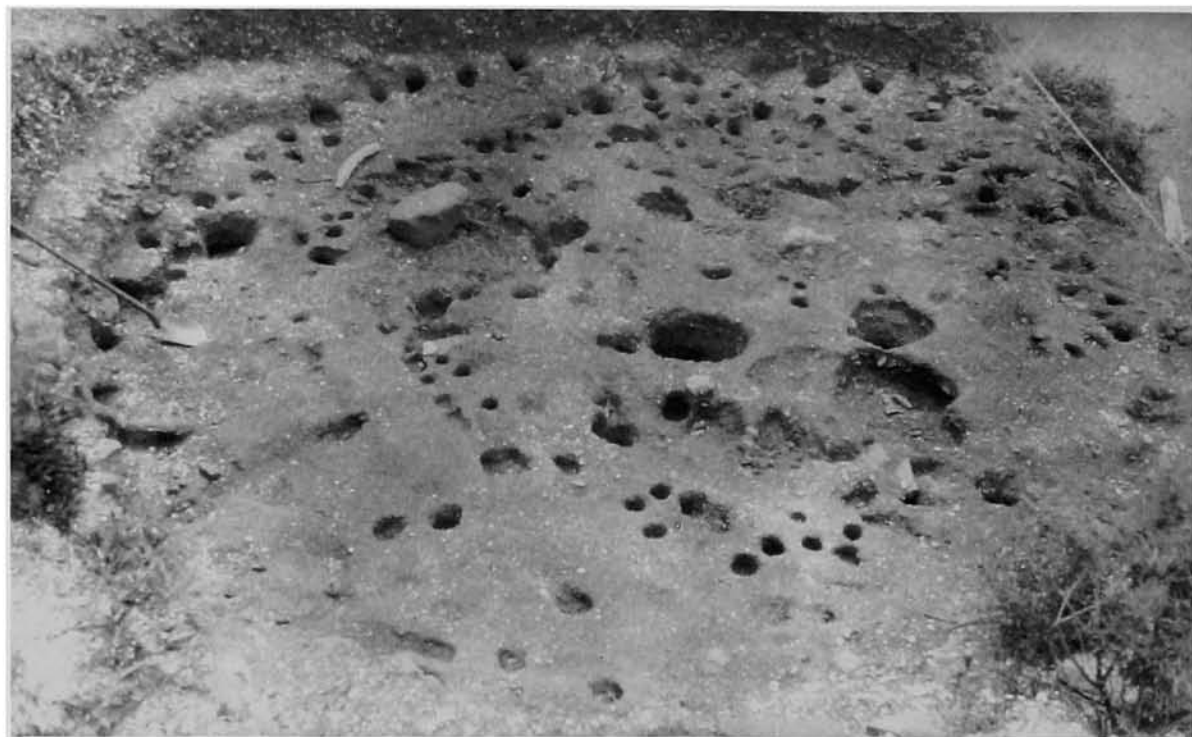
Fig. 12. Postholes and other features associated with House C at Muwu.

One hundred seventy-four postholes were encountered in the house (Fig. 12). In the field notes, two definite rings of postholes were observed near the perimeter. These postholes can be seen near the perimeter of the floor in Figure 13. In addition, random groups of postholes were encountered throughout the floor. Stumps of poles were occasionally observed, but the wood was so decayed that they were not recovered. Compact masses of eelgrass were encountered in various places across the floor. According to Woodward (MS), the angle in which the eelgrass lay indicated that it was part of the fallen roof. Eelgrass was probably abundant in

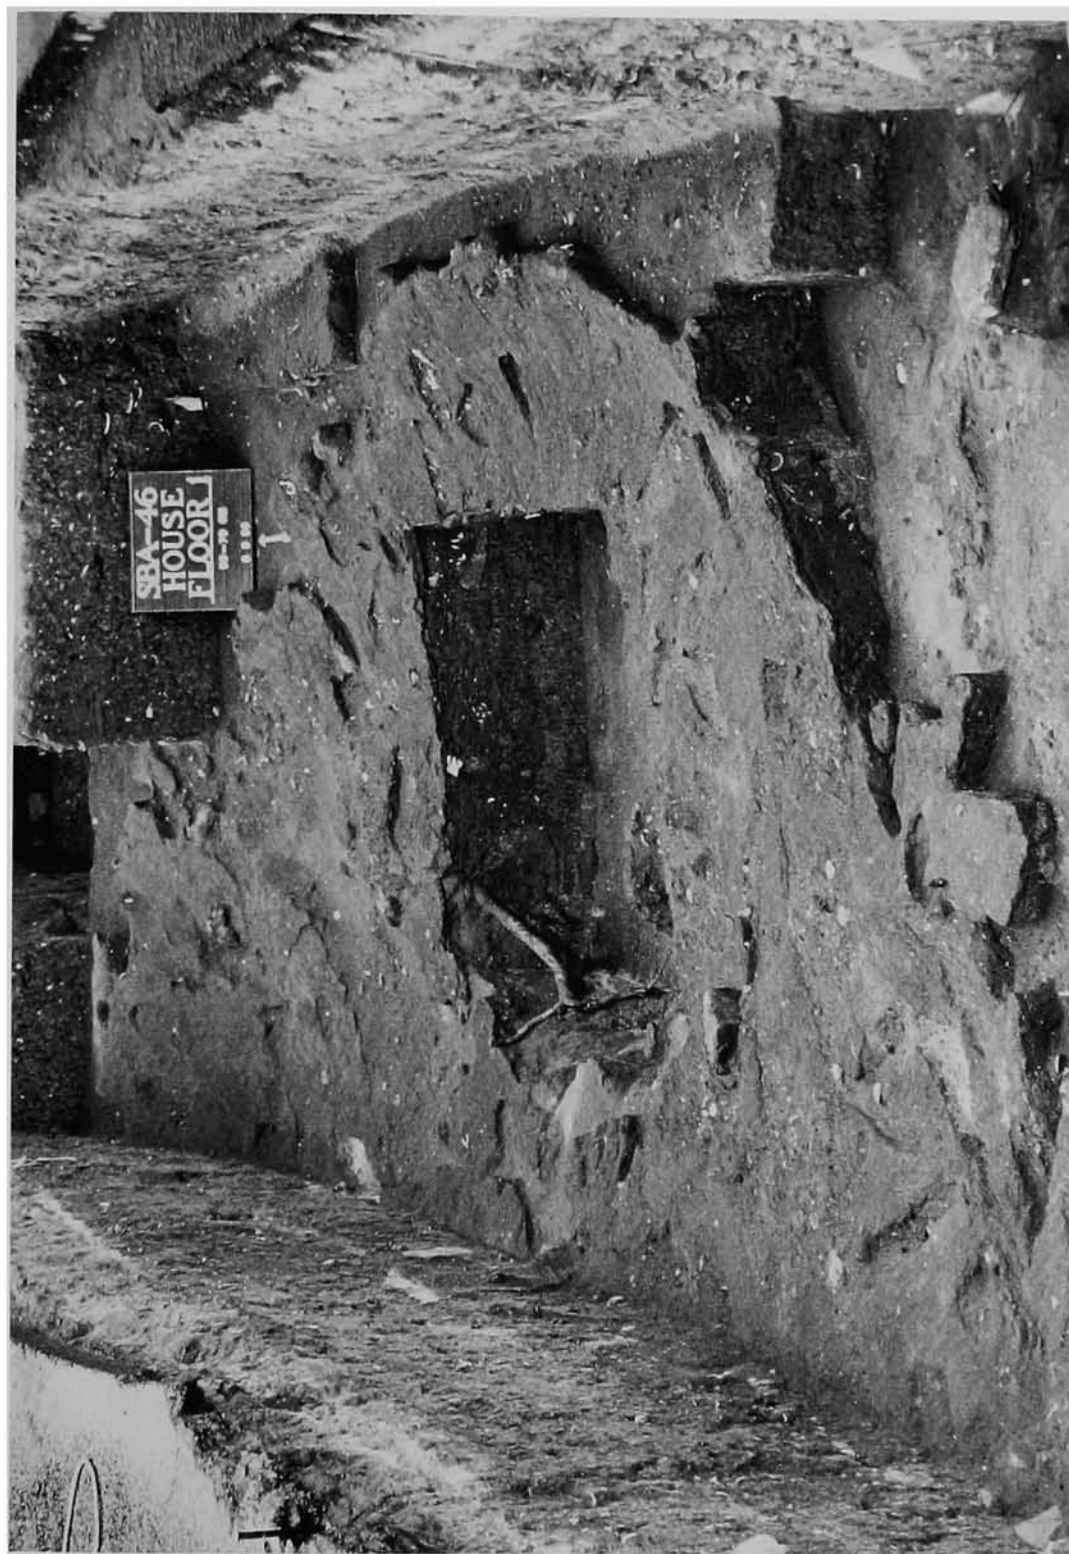
Fig. 15. Floor 1 at Helo, looking north.

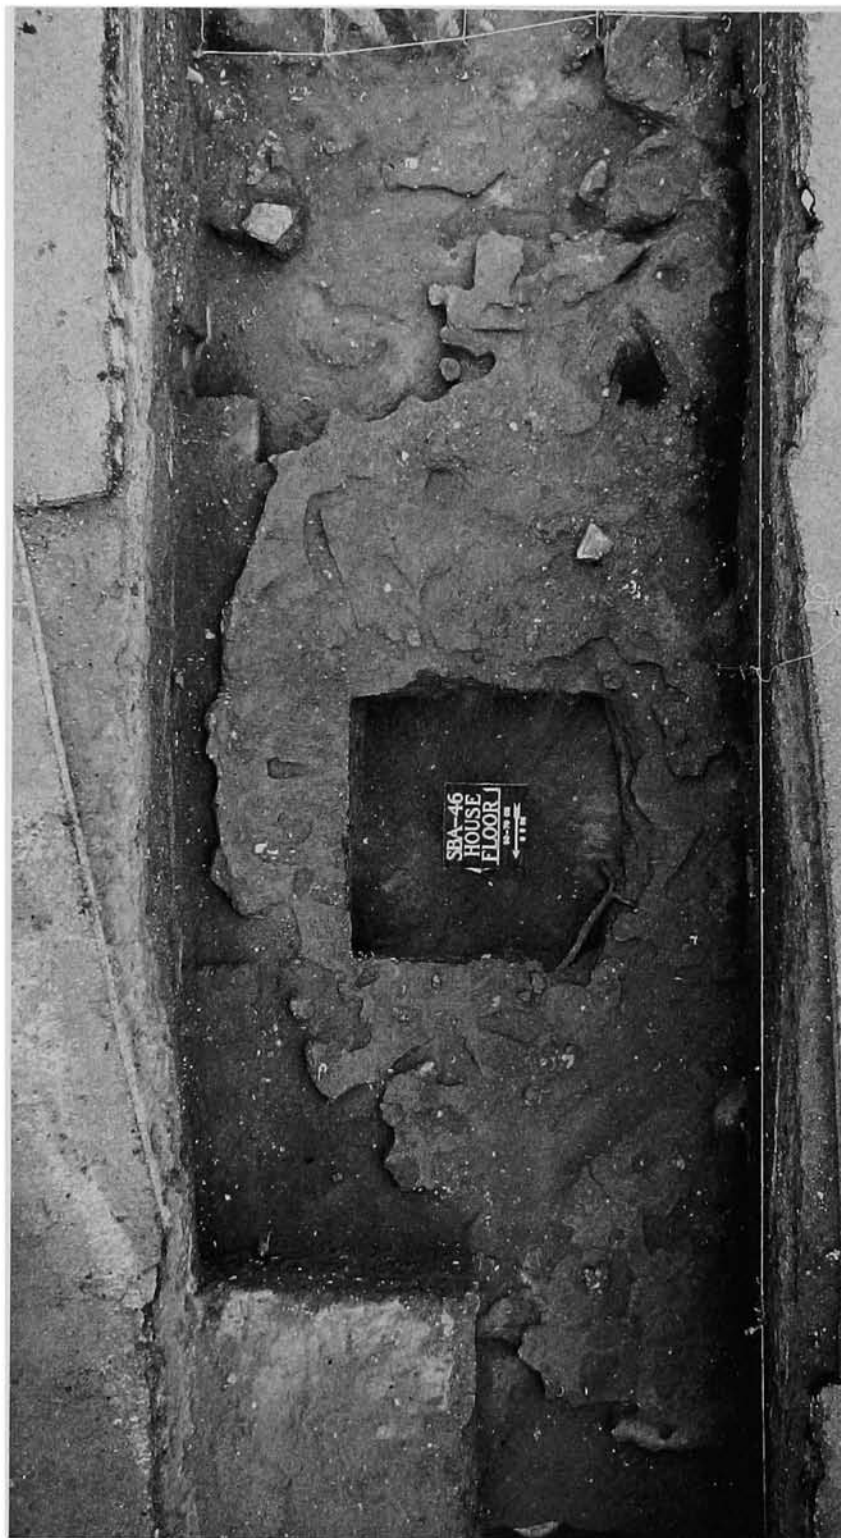
Fig. 16. Overhead view of Floor 1 at Helo.
